AWWA-HIWPS
Research Section

Assessment of the Maui 1 and 4 Shaft Wells

Presented by: Yvonne Cabrera

April 14, 2015

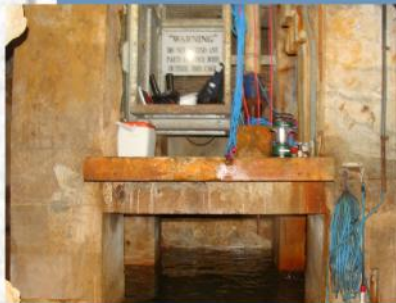
Maui 1

Platform and basin at the bottom of the shaft well

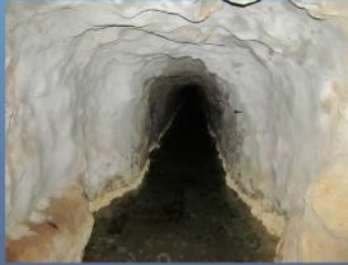
Maui 1

Southeast Infiltration Gallery
~200ft

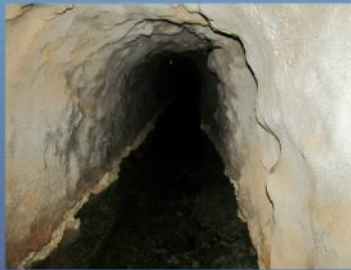
Maui 1

Southwest Infiltration Gallery
~200 ft long

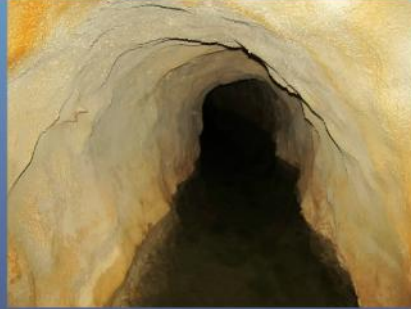
Maui 4

East Infiltration Galleries ~855ft

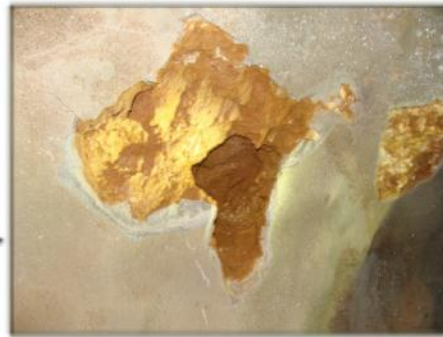
Maui 4

Tunnel lining damage in the east infiltration gallery

Remove Cave-in Material, Repair Concrete Lining and Clean Basin Free of Debris

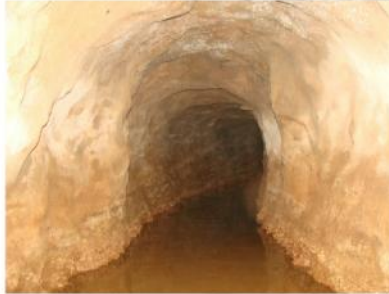
Maui 4

West Infiltration Galleries ~270ft

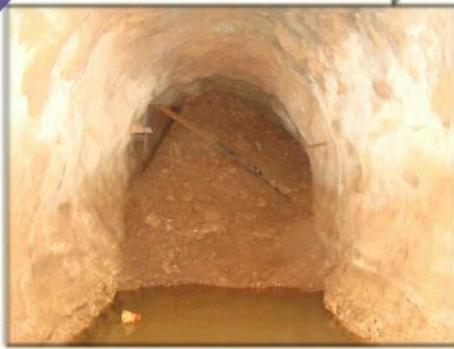
Maui 4

Cave-in at 70 ft into the West Infiltration Gallery

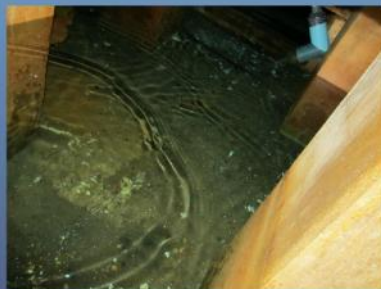
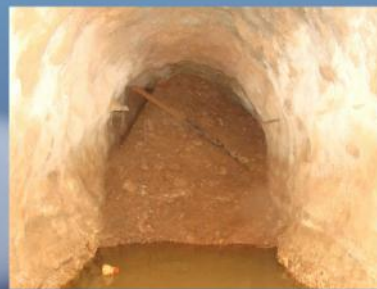
Cave-in and Debris in the Basins
